PROJECT: ROM – Michael Lee Chin Crystal

Type of Work: Refinishing of structural steel window mullion assemblies.

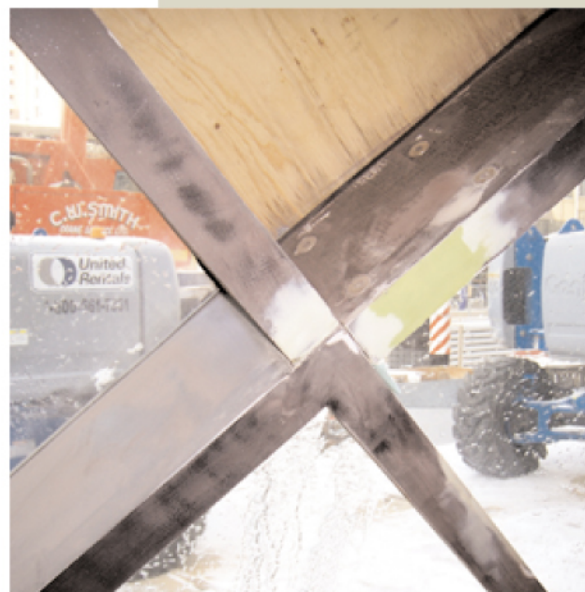
BEFORE RESTORATION

Overview: Large steel window mullions shipped from Germany as finished product are damaged in shipping and installation.

Extensive cleaning (SSPC-SP-1), sanding (SSPC-SP-2 & 3) and body filling were required to fill the numerous scratches, gouges and dents in the metal and to prepare them for refinishing.

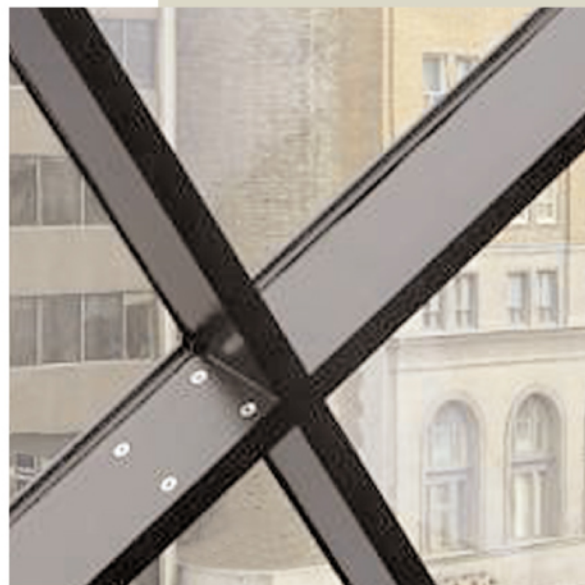
AFTER RESTORATION

The results were excellent despite the very difficult working conditions – tight spaces, odd angles, and other trades working in the same areas.
